**Gravelbourg Saskatchewan Multi-Legged Tank
Remote Inspection & Report
June 19, 2018**

July 18, 2018

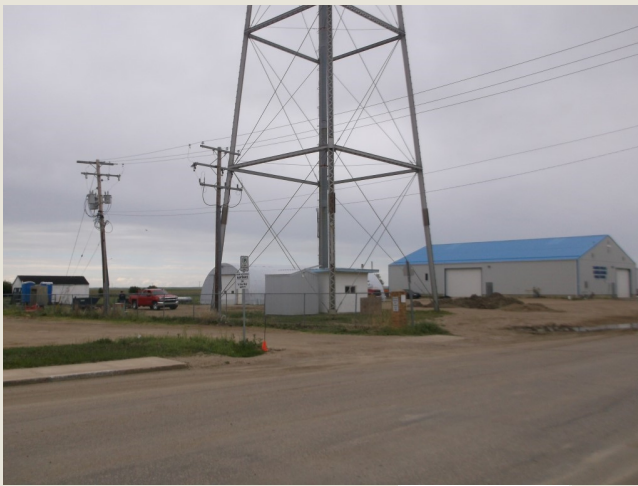
4pc Rescue port bases are required

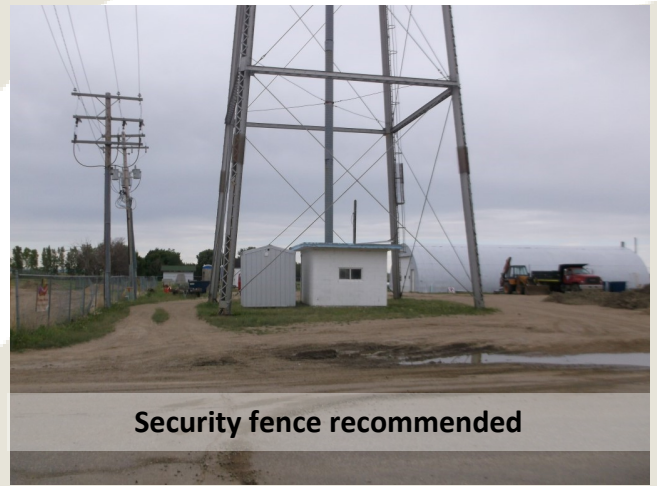
Security fence recommended

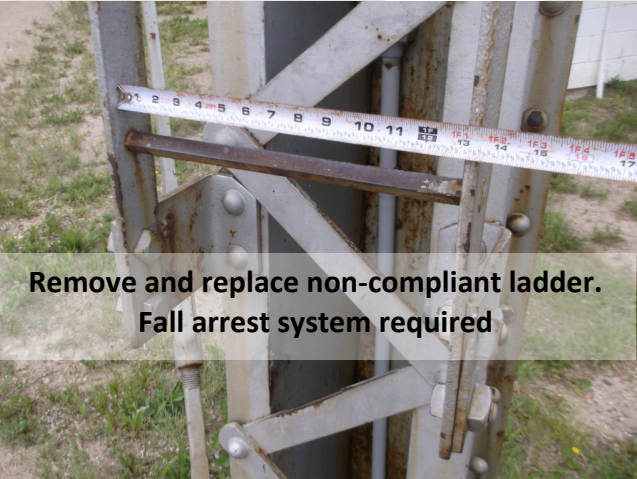
**Remove and replace non-compliant ladder.
Fall arrest system required**

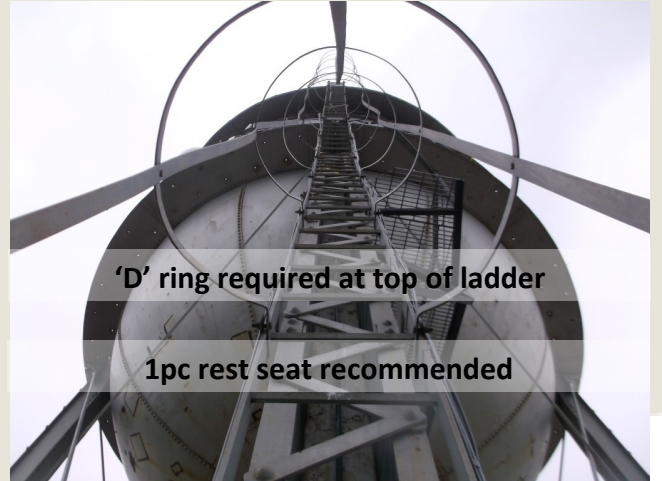
'D' ring required at top of ladder

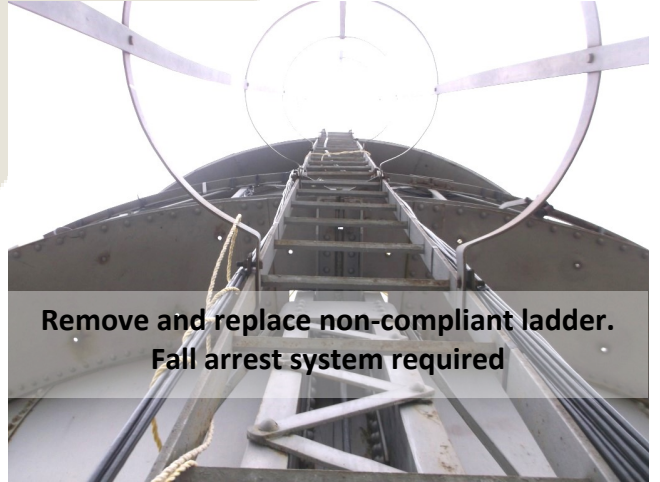
Remove and replace non-compliant ladder.
Fall arrest system required

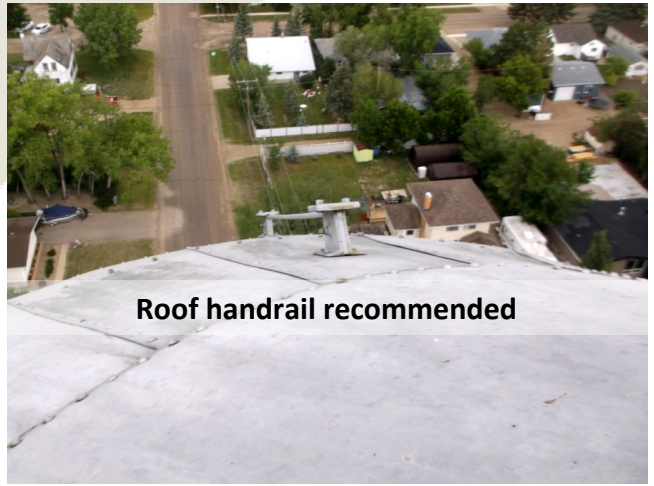
Roof handrail recommended

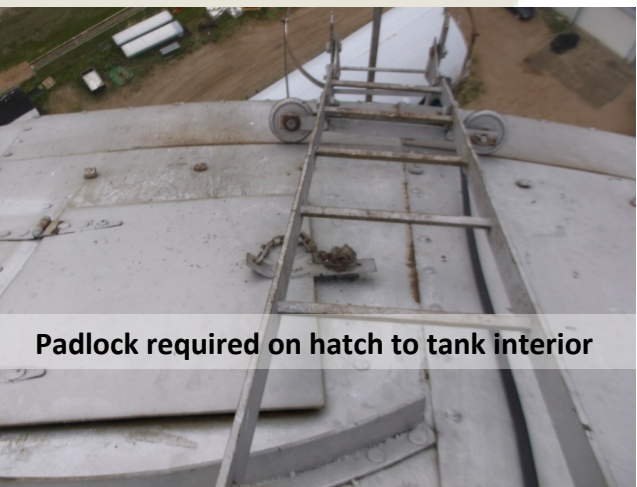
Padlock required on hatch to tank interior

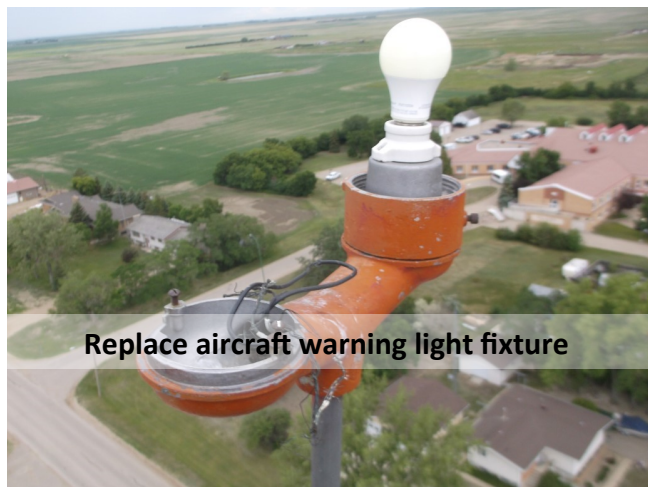
Replace aircraft warning light fixture

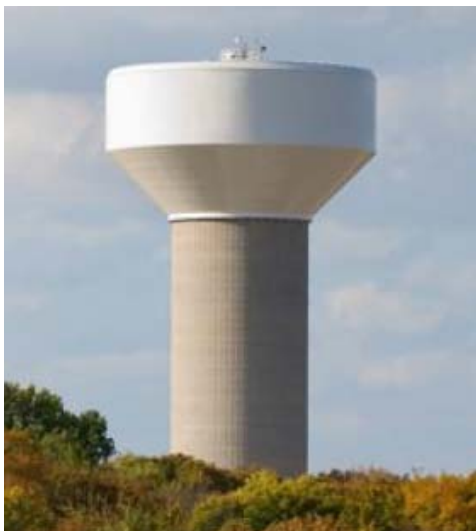
Lifecycle cost results, 40 Year Period:

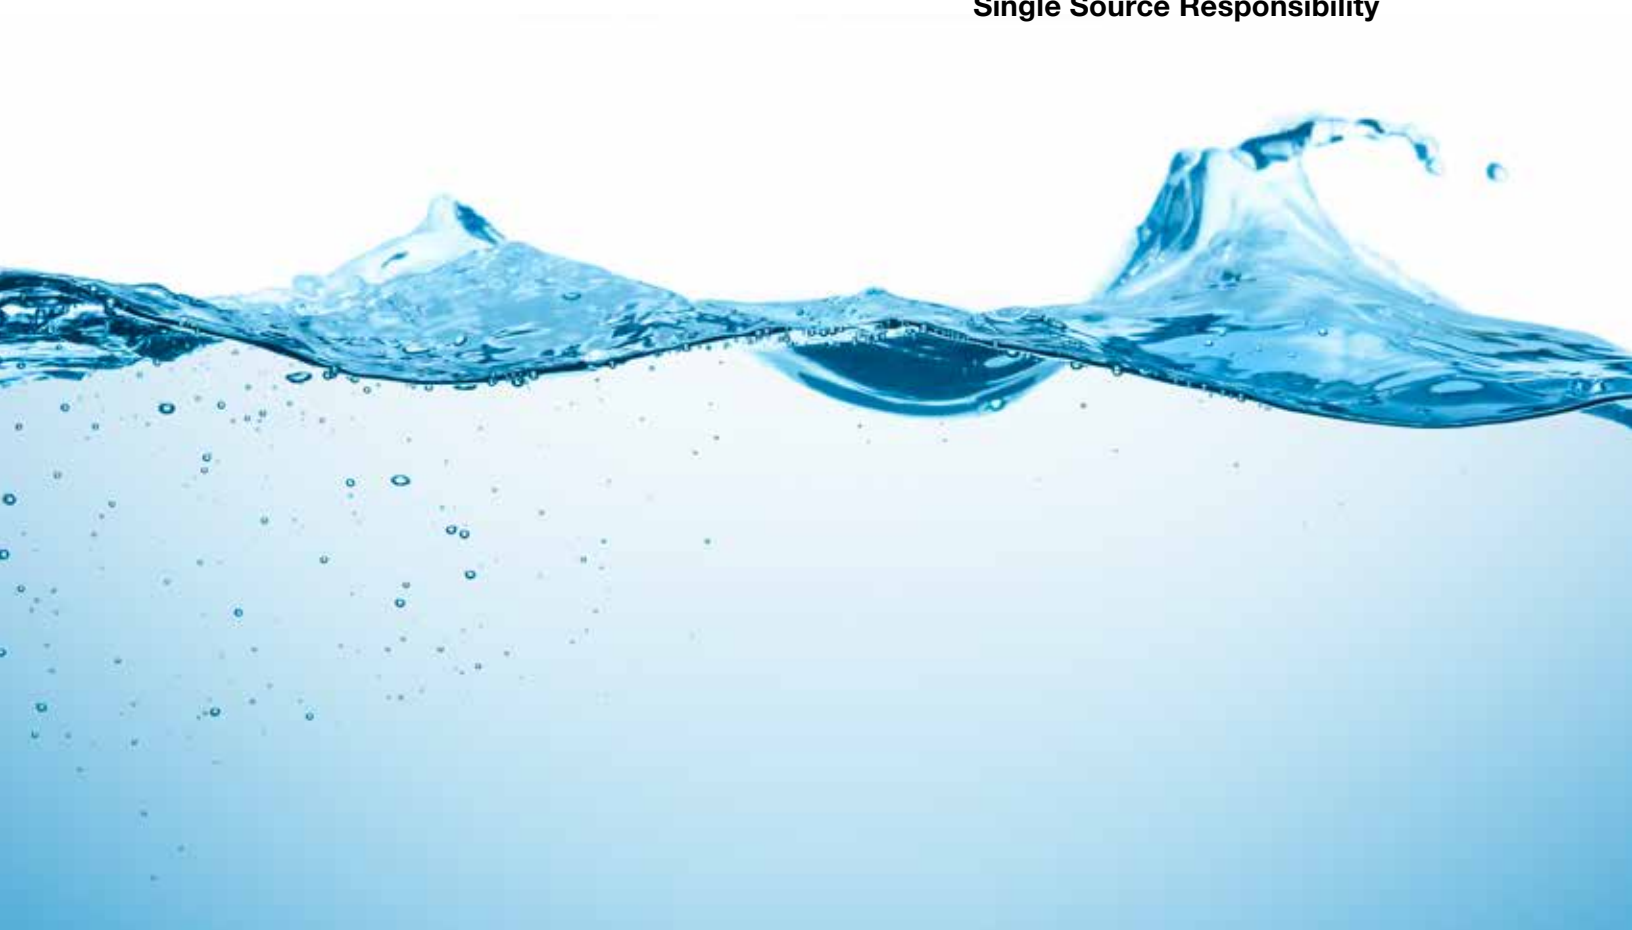
Expert Inspection, Maintenance And Repairs
For All Types Of Water Storage Tanks

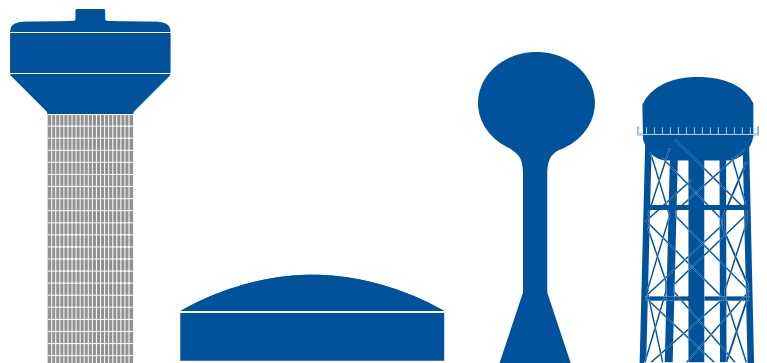
Expert inspection, maintenance, and repairs for all types of water storage tanks

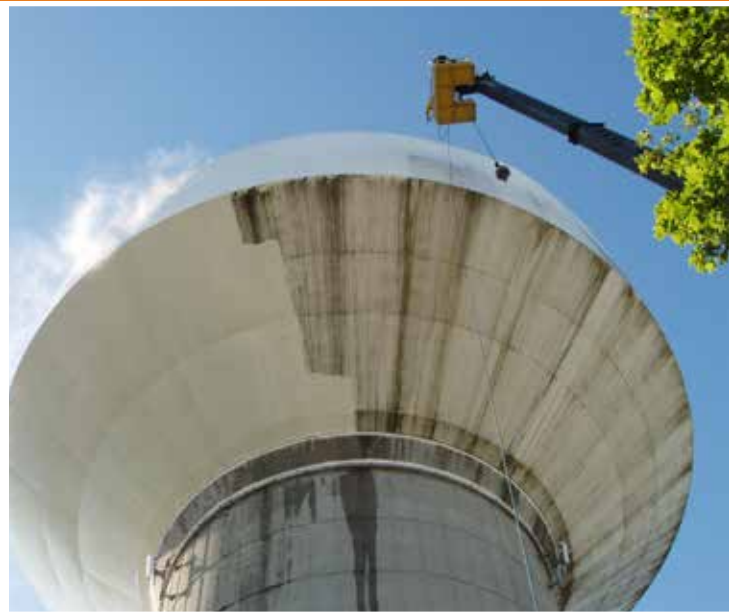
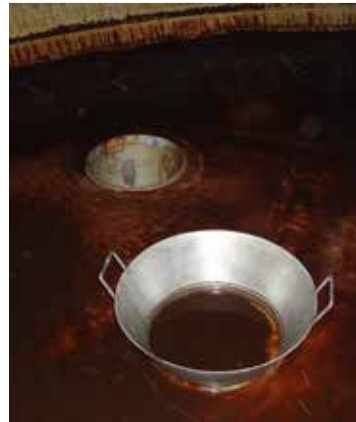
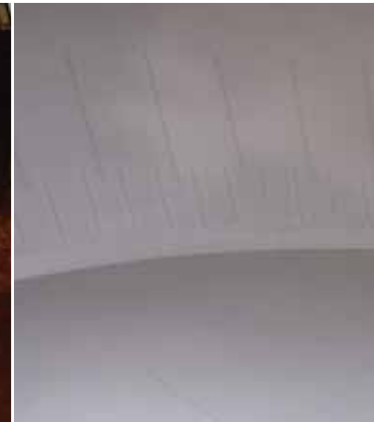
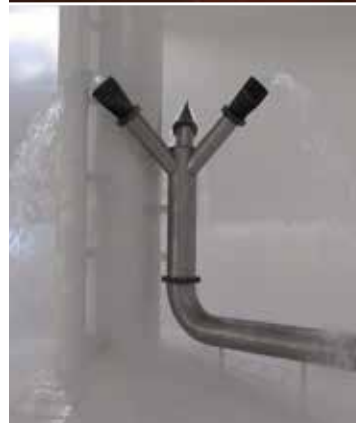
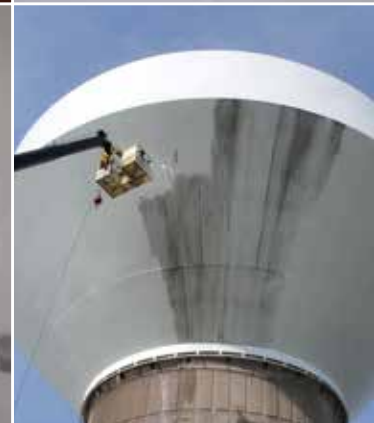
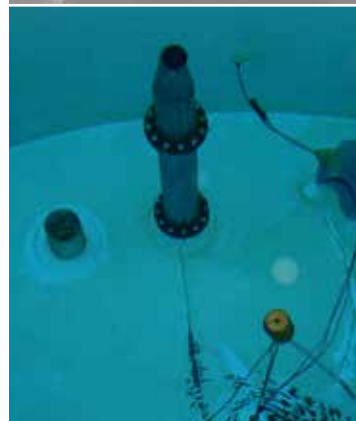
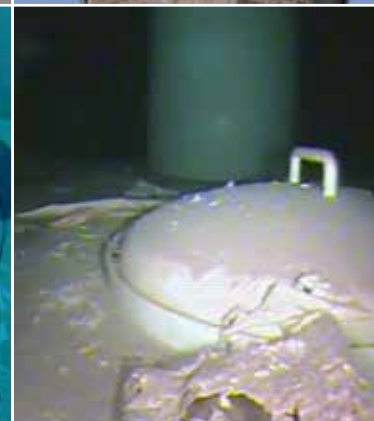
Safety Upgrades and Training

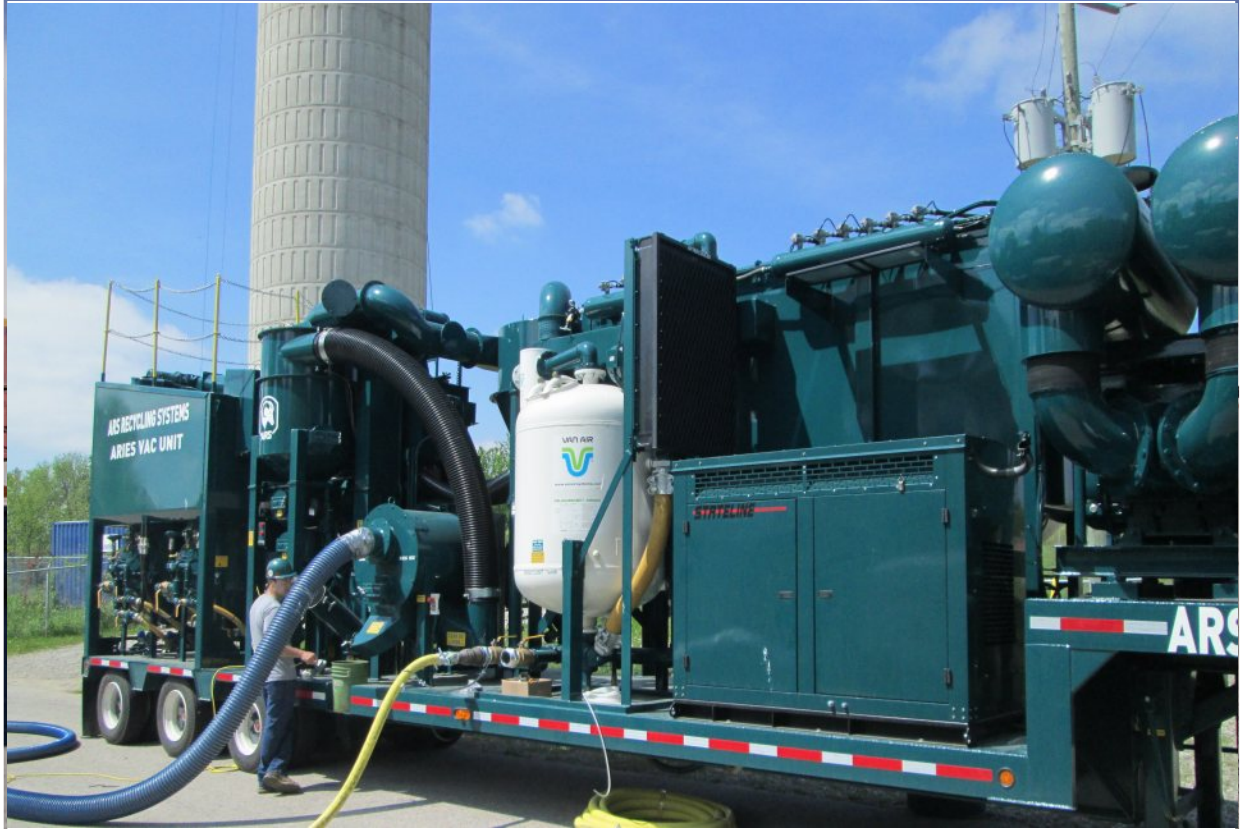
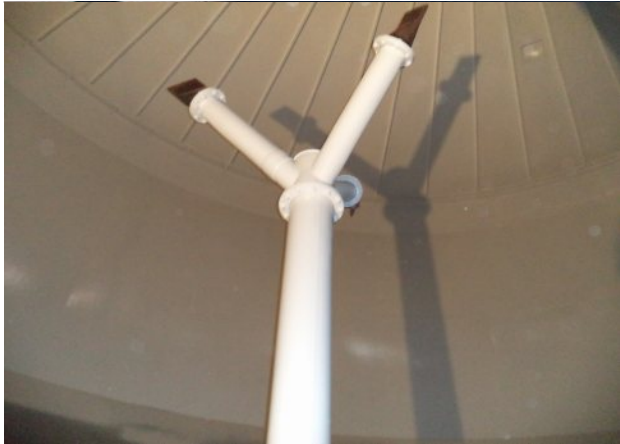
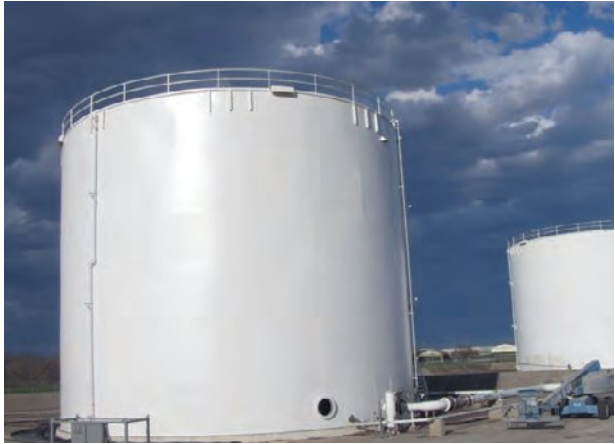
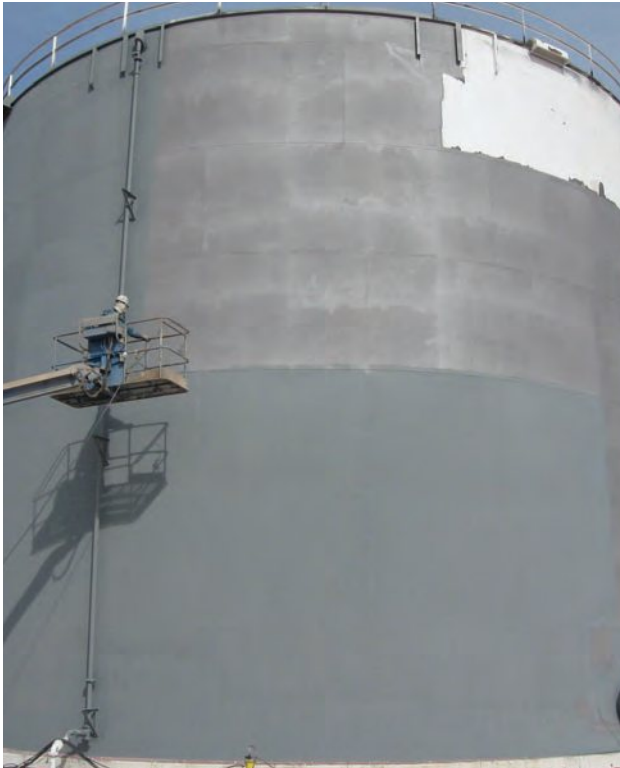
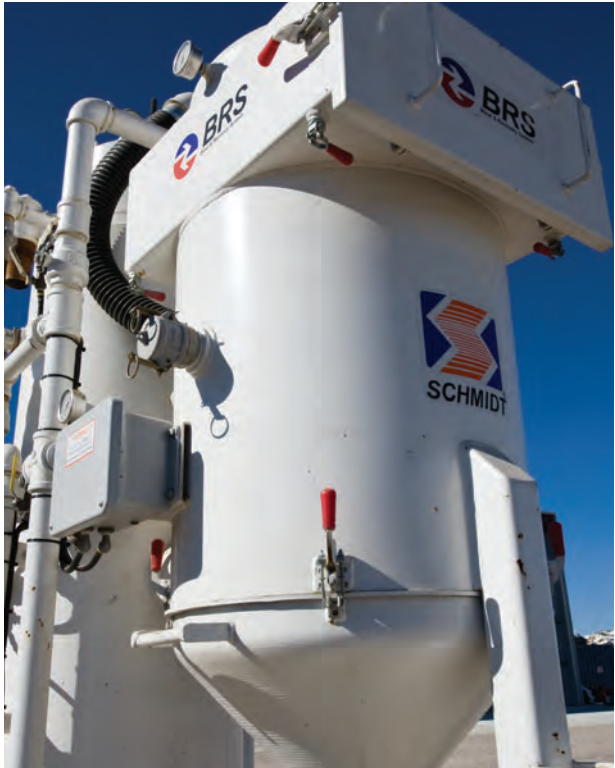
Routine quality evaluations include but are not limited to:
